Manhole Inspection Summary

Manhole # S49A__059MH

Insp Date: **4/30/09 3:49 PM**

Location Address: **438 ROSE-LUZERNE-ALLEY**

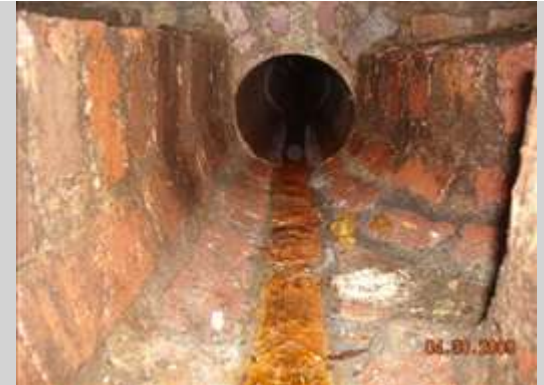
12 O'Clock Outflow

8 in. Circular Gravity Sewer
Pipe Out @ 12 O'Clock

Pipe Height: **8.4** (in.) Rod and Bar (Angled)
Pipe Material: **Clay** ☐ Pipe Lined
Invert Depth: **9.40** (ft.) Flow Characteristics: **Slow**
Deposits: ☒ None ☐ Mud ☐ Sludge ☐ Debris ☐ Grease
Silt Depth: **0** (in.) Deposits Extent:
Infiltration: **None** Pipe Seal Cond: **Sound**

Drop: **None**

Connects To: **Manhole**

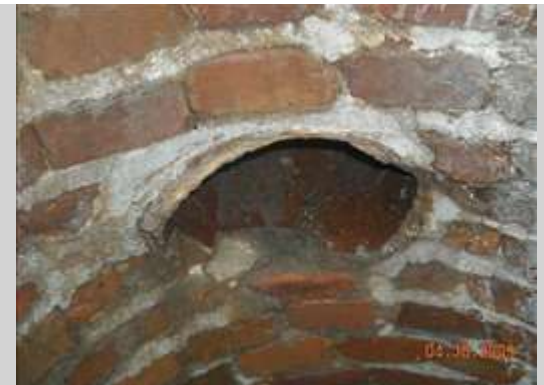
3 O'Clock Inflow

8 in. Circular Gravity Sewer
Pipe In @ 3 O'Clock

Drop In @ 3 O'Clock

Pipe Height: **8.4** (in.) Rod and Bar (Angled)
Pipe Material: **Clay** ☐ Pipe Lined
Invert Depth: **2.75** (ft.) Flow Characteristics: **Slow**
Deposits: ☒ None ☐ Mud ☐ Sludge ☐ Debris ☐ Grease
Silt Depth: **0** (in.) Deposits Extent:
Infiltration: **None** Pipe Seal Cond: **Sound**

Drop: **Outside** Rod and Bar
Angled: **Yes** Reading: **8.30** (ft.)
Inv Depth: **9.30** (ft.)

Drop Condition: **Open**

Connects To: **Dead End**

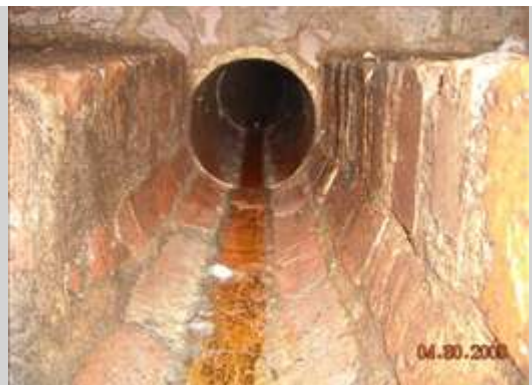
6 O'Clock Inflow

8 in. Circular Gravity Sewer
Pipe In @ 6 O'Clock

Pipe Height: **8.4** (in.) Rod and Bar (Angled)

Pipe Material: **Clay** ☐ Pipe Lined

Infiltration: **None** Pipe Seal Cond: **Sound**
